Steelhead Recovery in Latah County

2023 Family Forest Landowners & Managers Conference

Brenda Erhardt, Resource Conservation Planner

Latah Soil and Water Conservation District

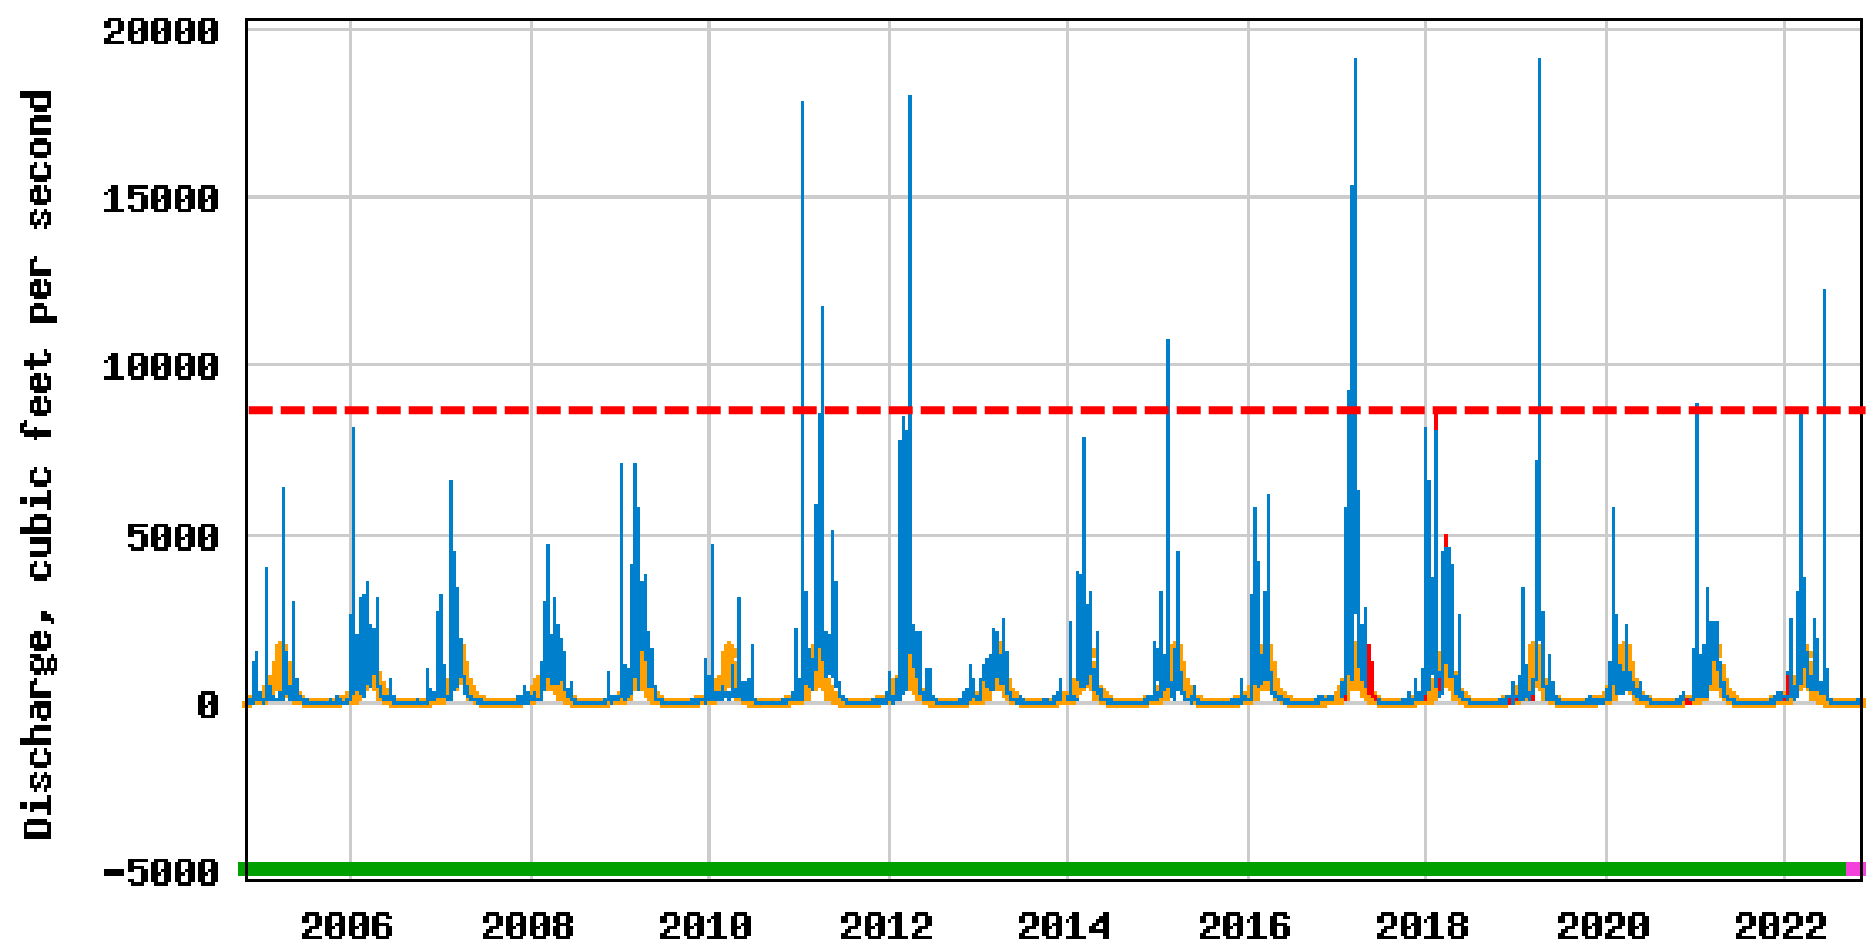
USGS 13341570 POTLATCH RIVER BEL LITTLE POTLATCH CR NR SPALDING

Peak flows in 1950s-1960s

- Median daily statistic (18 years)
- Discharge
- Estimated discharge
- Period of approved data
- Period of provisional data

~ 15,000 cfs @ 8:00 am – current photo
~ 19,000 cfs @ 3:00 am

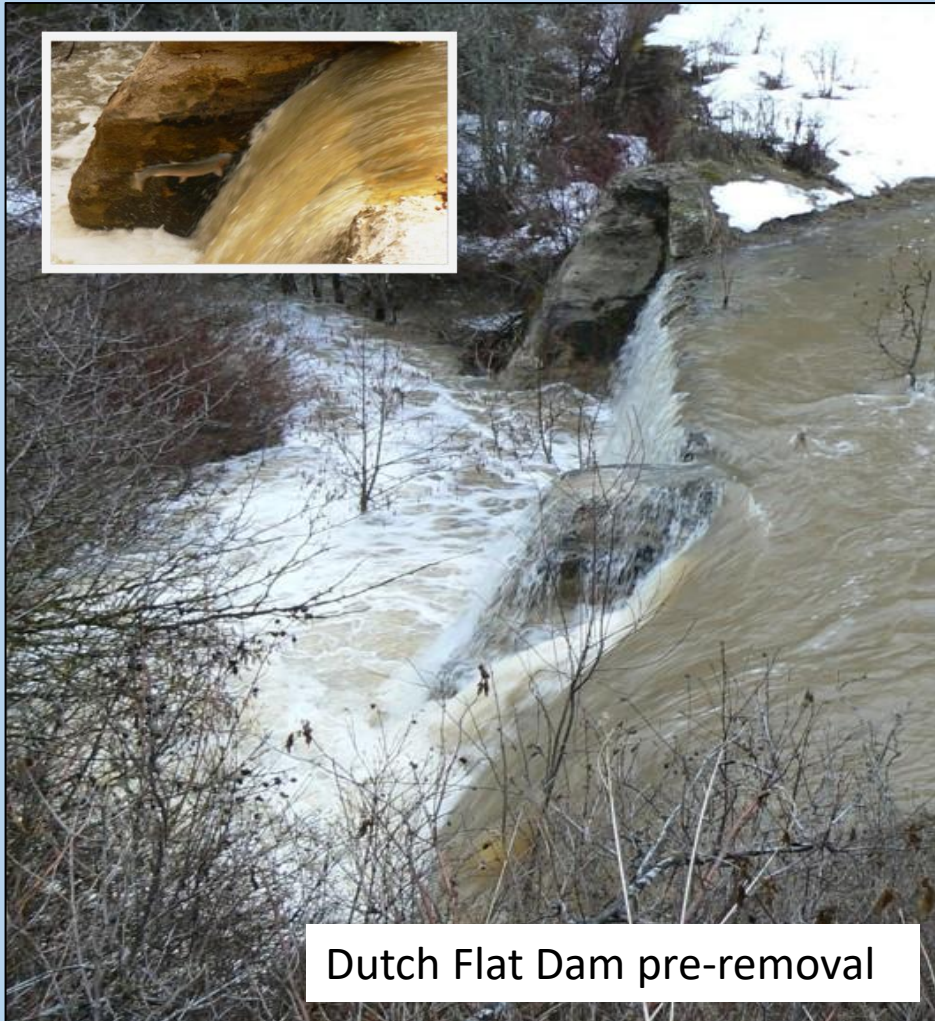
Dutch Flat Dam pre-removal

Dutch Flat Dam (2013 project) – West Fork Little Bear Creek, opened 14 stream miles

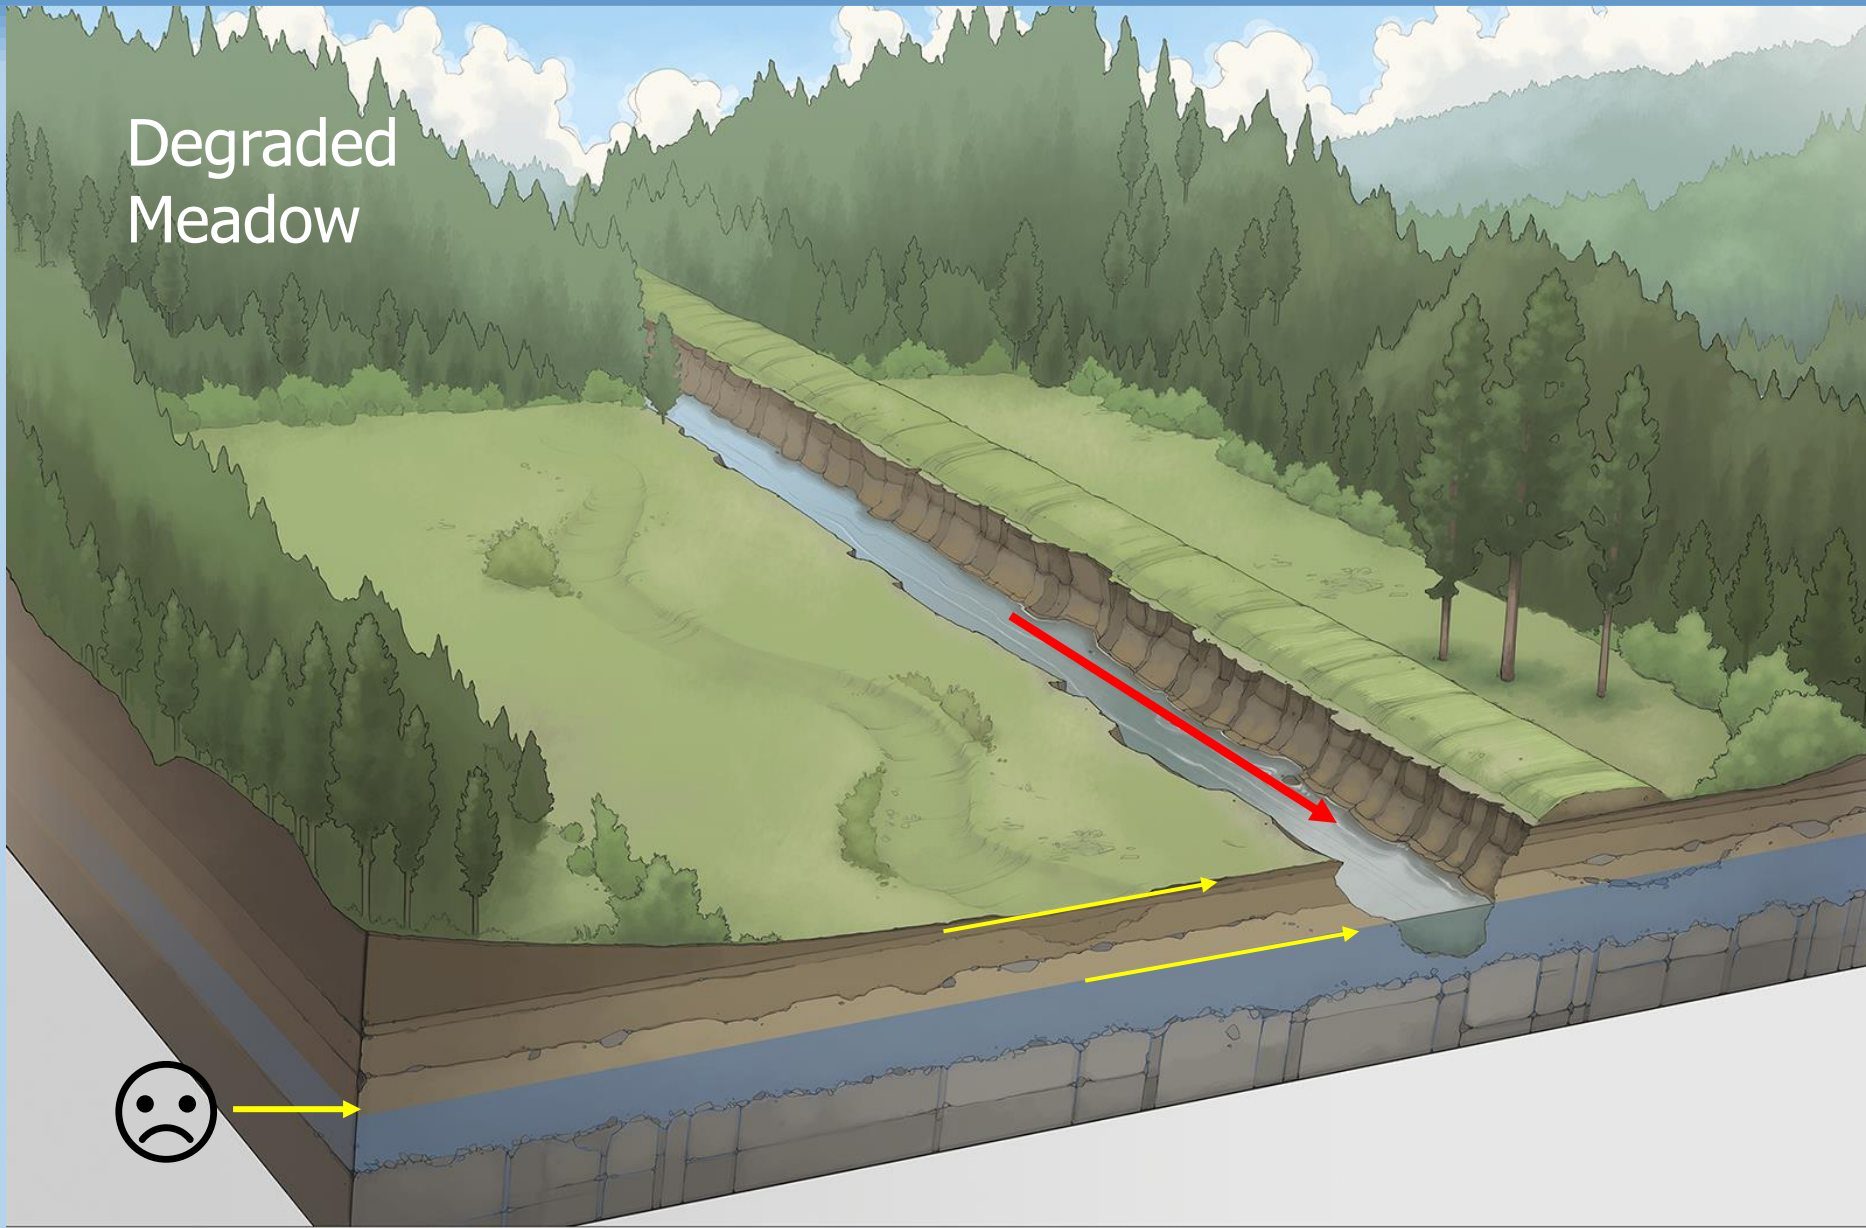
Degraded Meadow

Problems:

It's **Deep**

- Water table depressed
- No hyporheic exchange
- Flood flows stay in channel

It's **Fast** – Energy regime is messed up

It's **Eroding** – Getting wider and deeper ²⁰

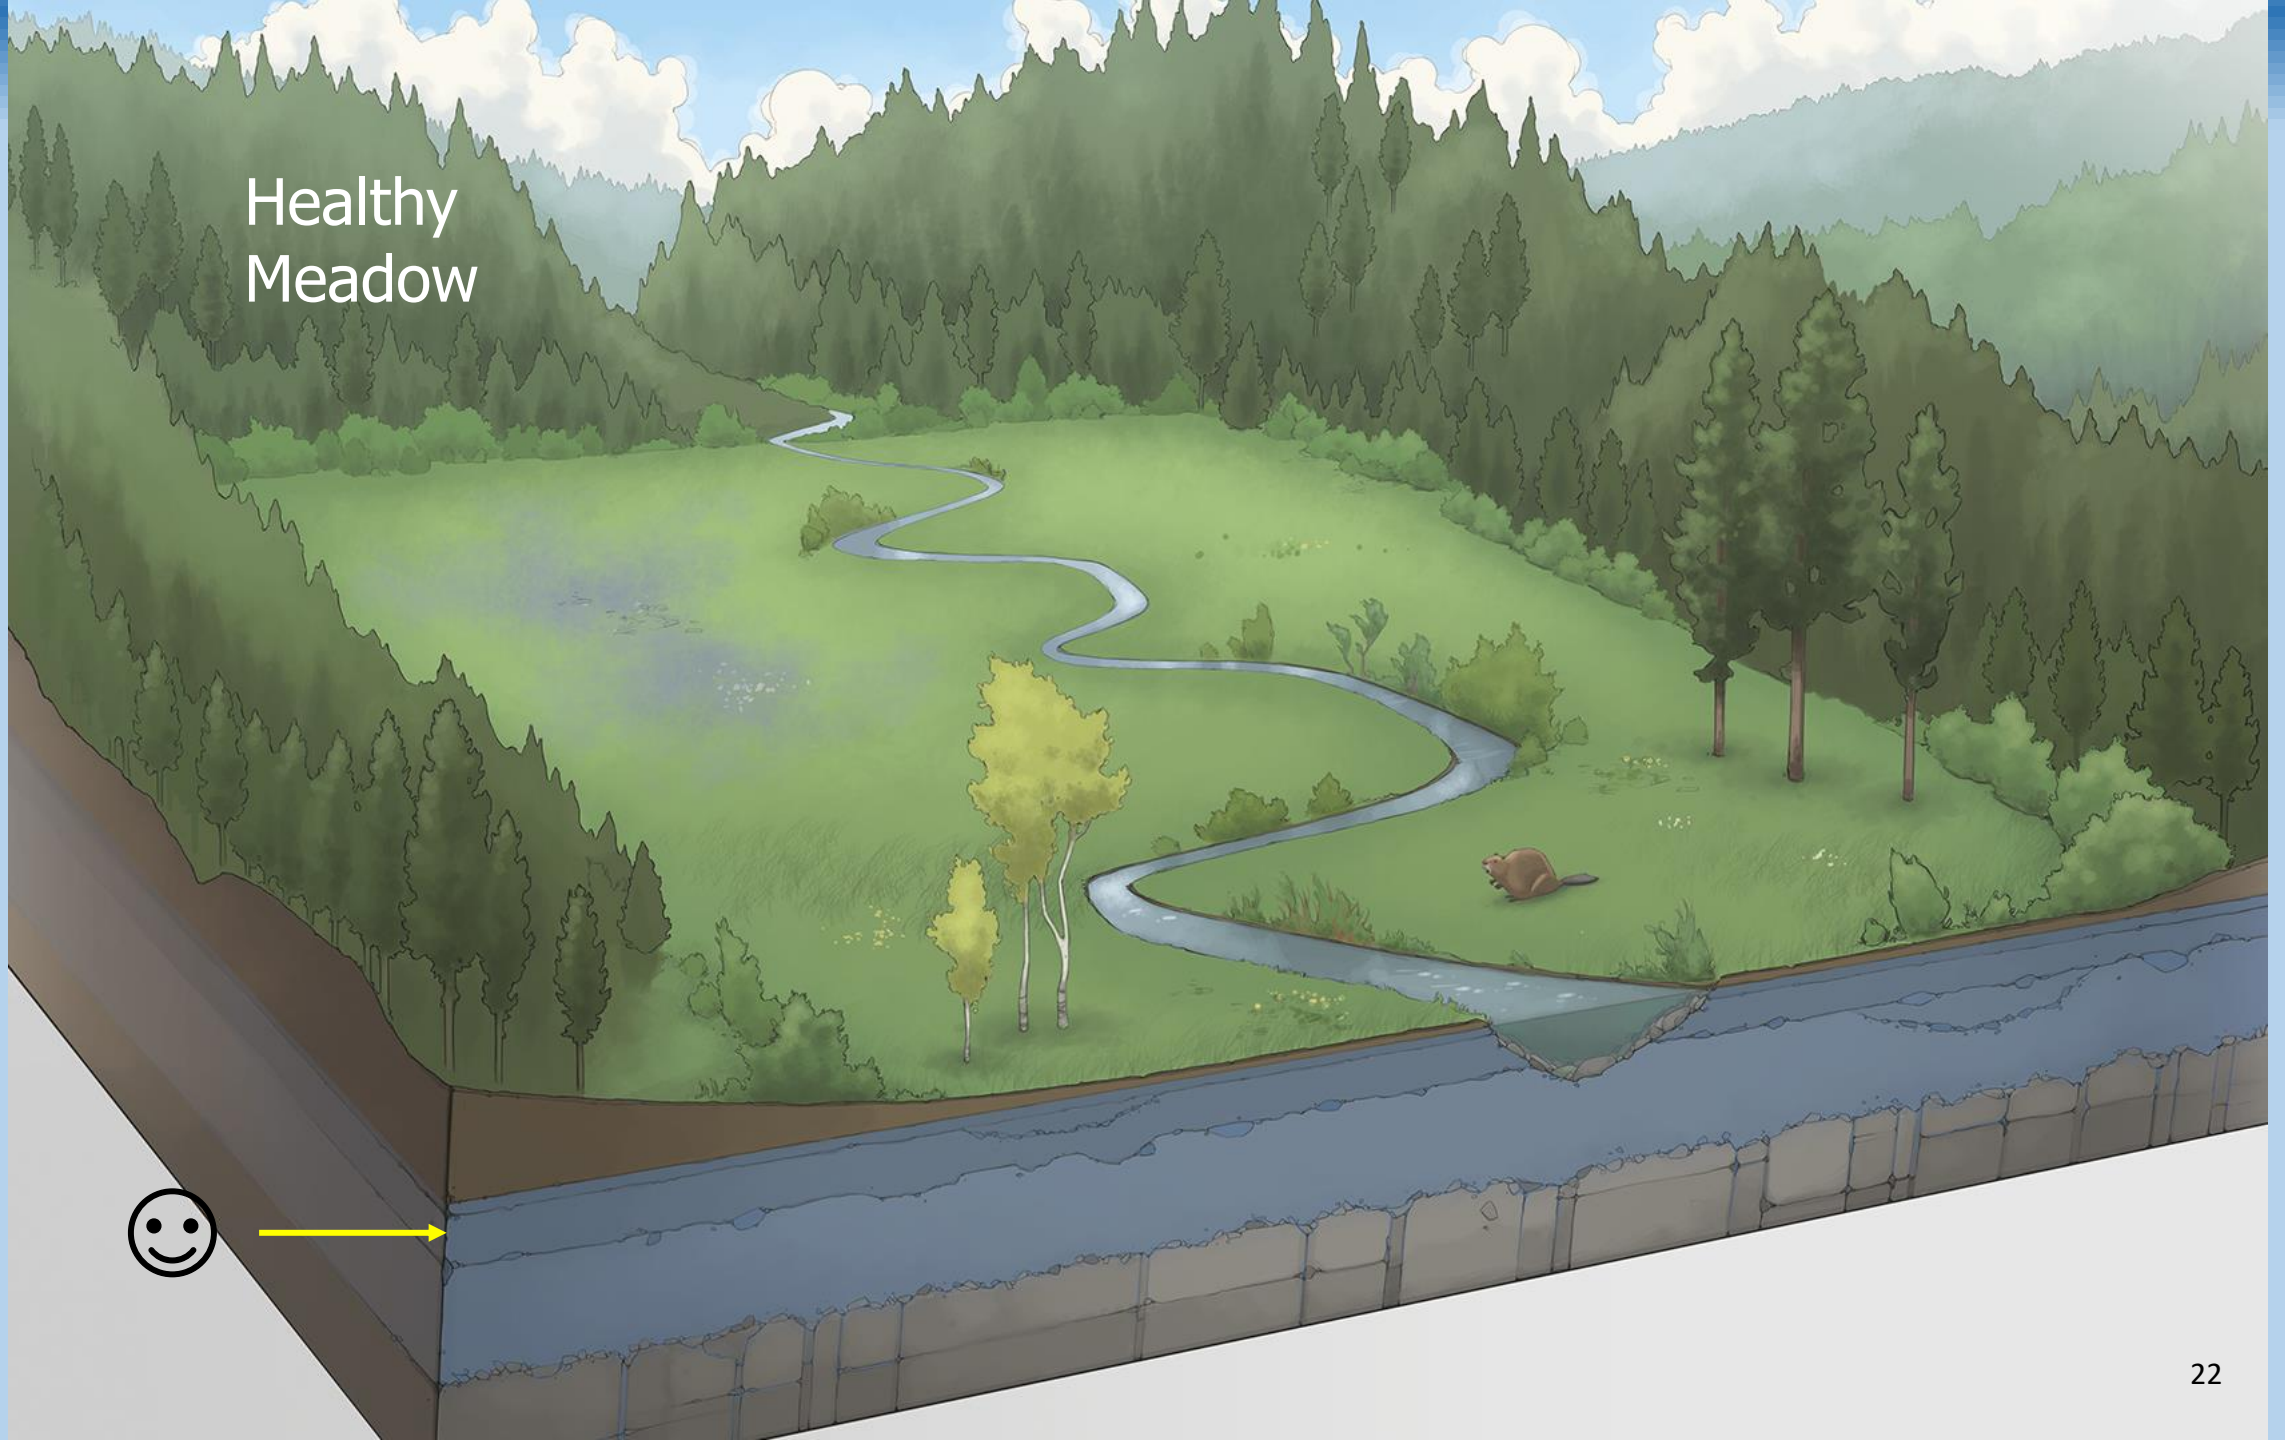
Healthy Meadow

Sinuuous channel, slower flows, riparian zone vegetation more attractive to beavers

Wet meadow supports diverse mosaic of habitats

Frequent inundation allows sediment deposition and attenuates peak flood flows

Riparian zone provides wood, leaf packs for channel complexity, food for macroinvertebrates

Flooding increases infiltration, percolation, and groundwater recharge

High water table supports wet meadow/wetland vegetation

High water table provides cool late-season base flows

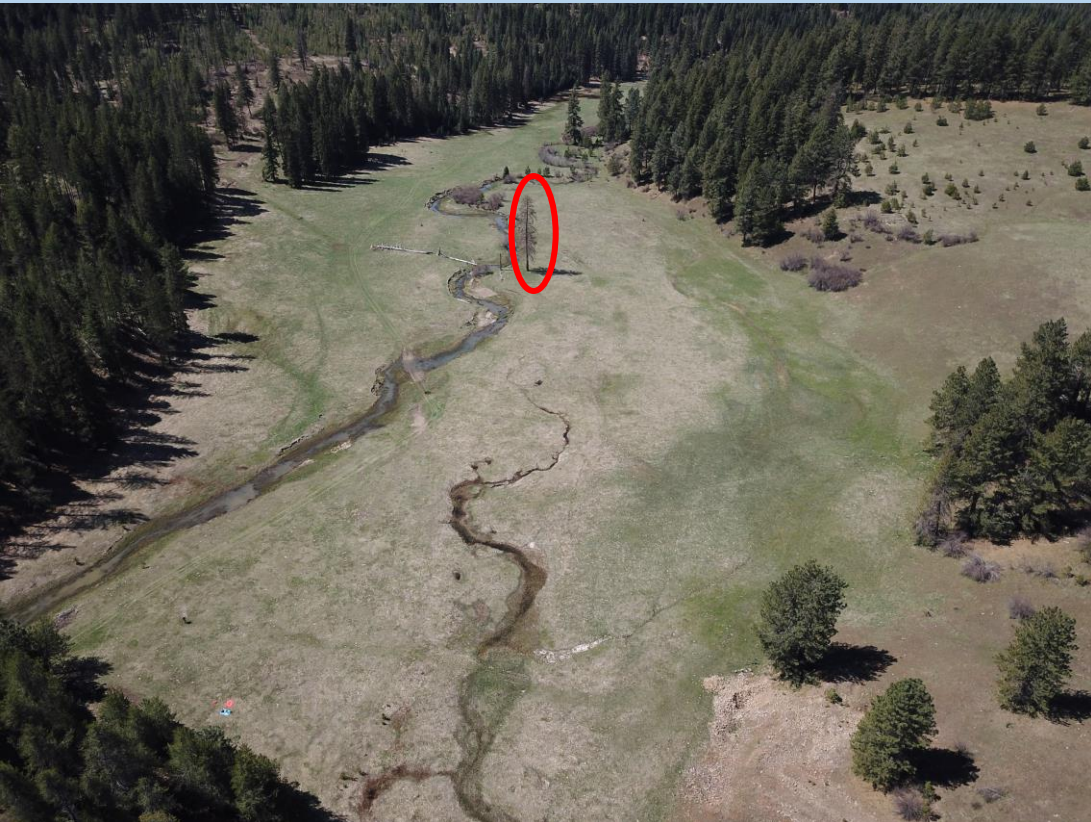
April 28, 2021, pre-construction

Project Metrics:
Treated Area – 49 acres
Treated Stream length – 1.28 miles

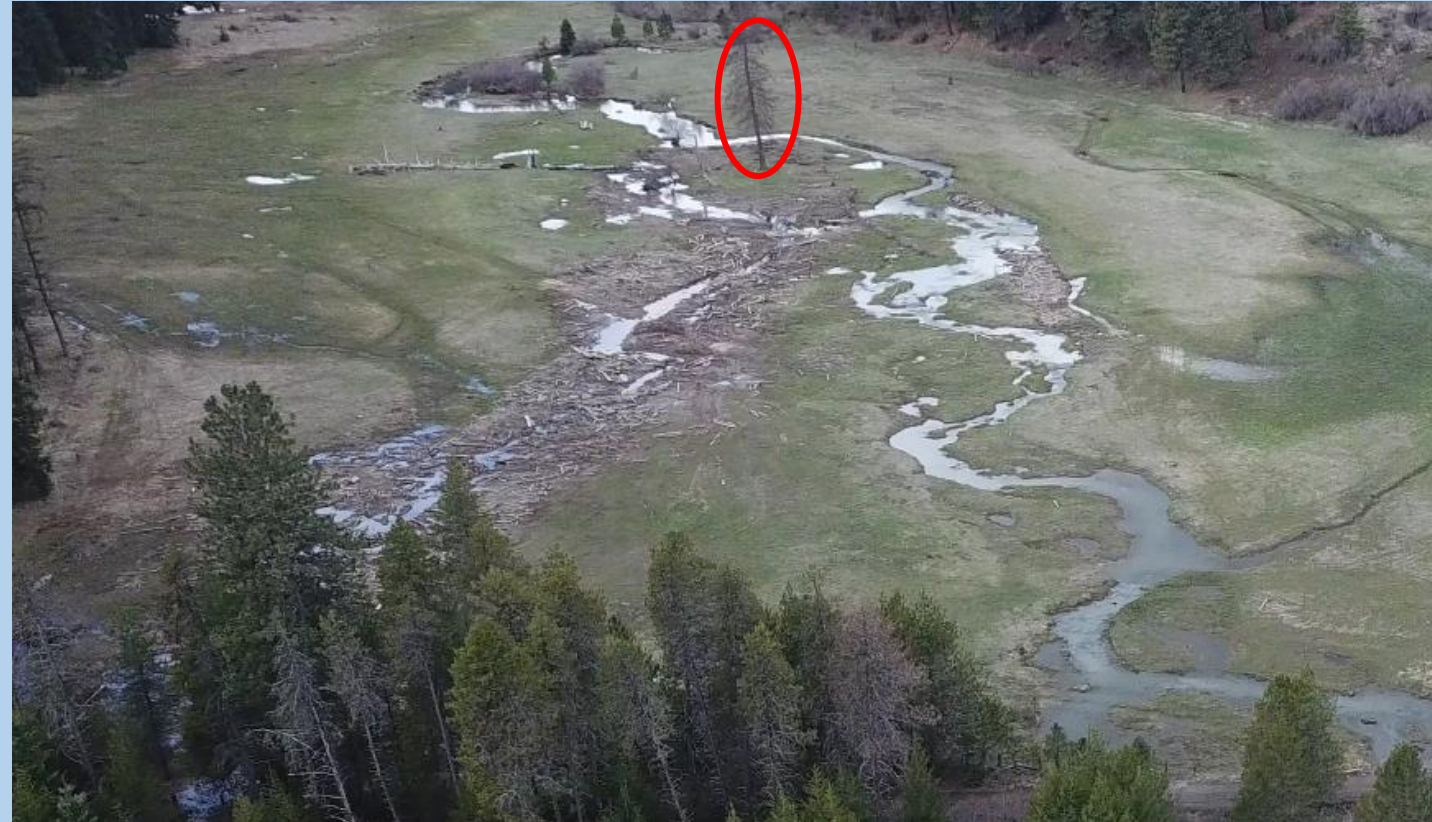
March 31, 2022, post-construction

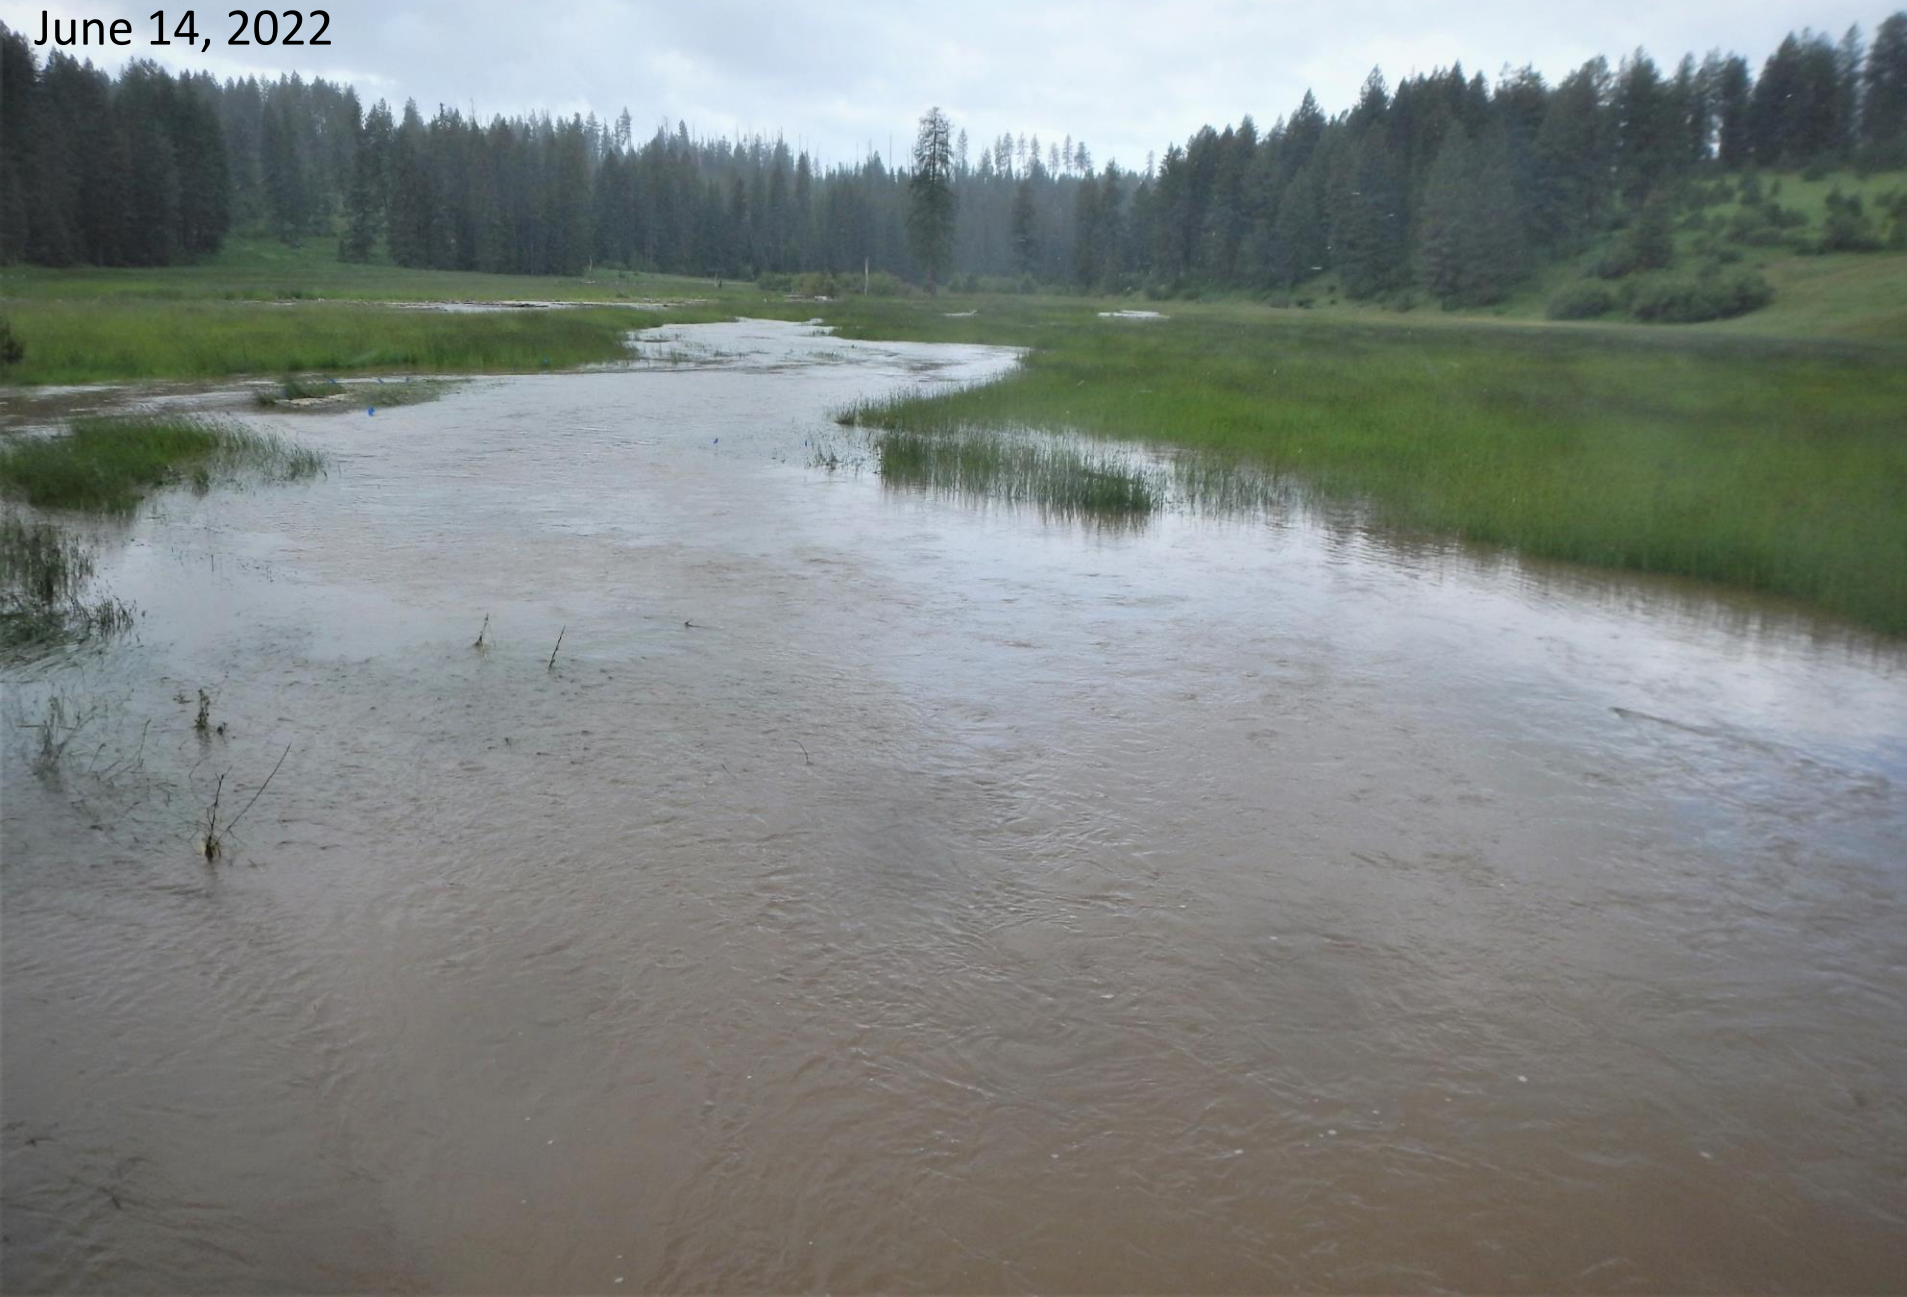
June 14, 2022

Goals achieved:

- Flow path altered
- Floodplain reconnected

Still to do:

- Add habitat complexity (more wood)
- Riparian vegetation

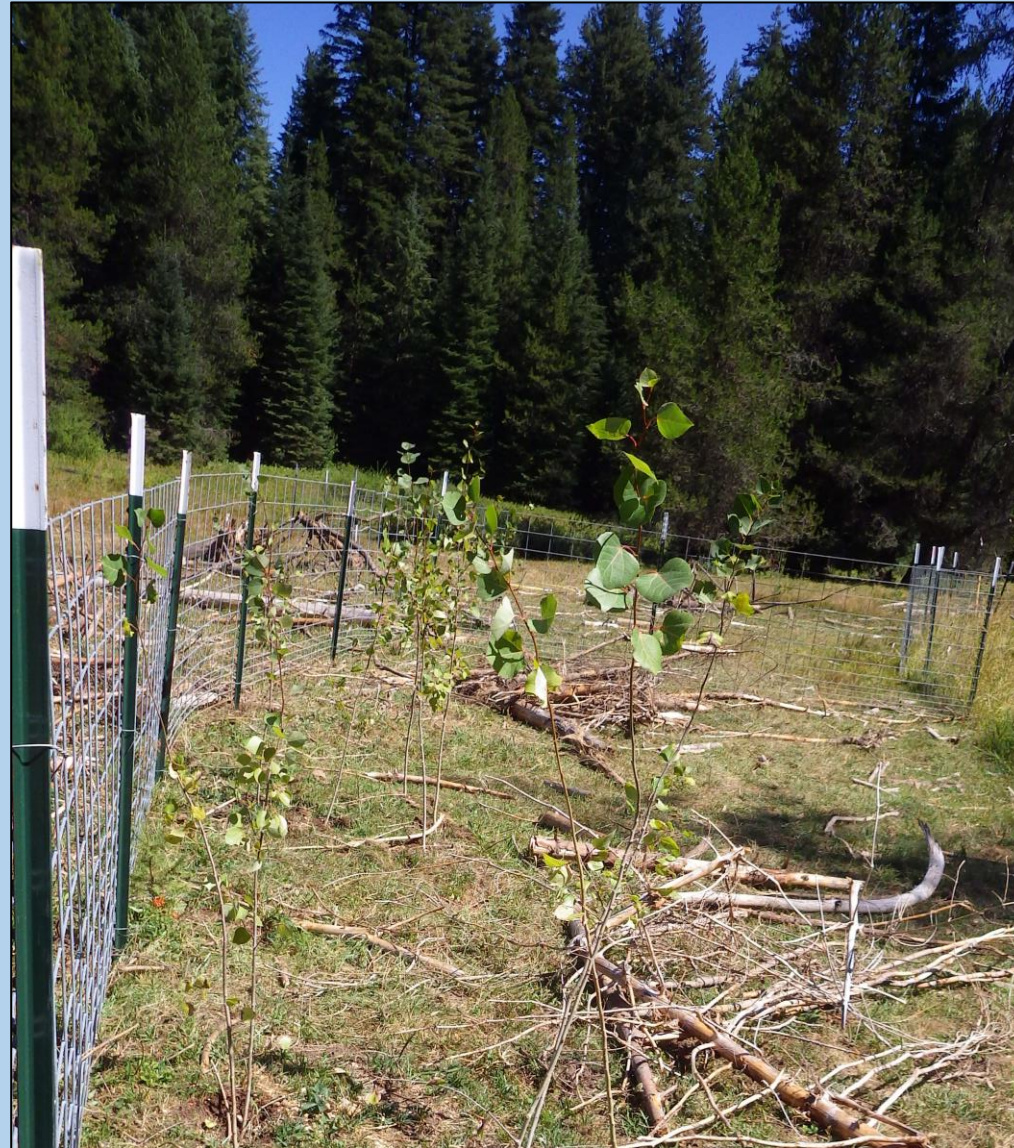
Exclosure Fencing

- Sturdy
- Reusable
- Easy to install
- Prevents browse and raking

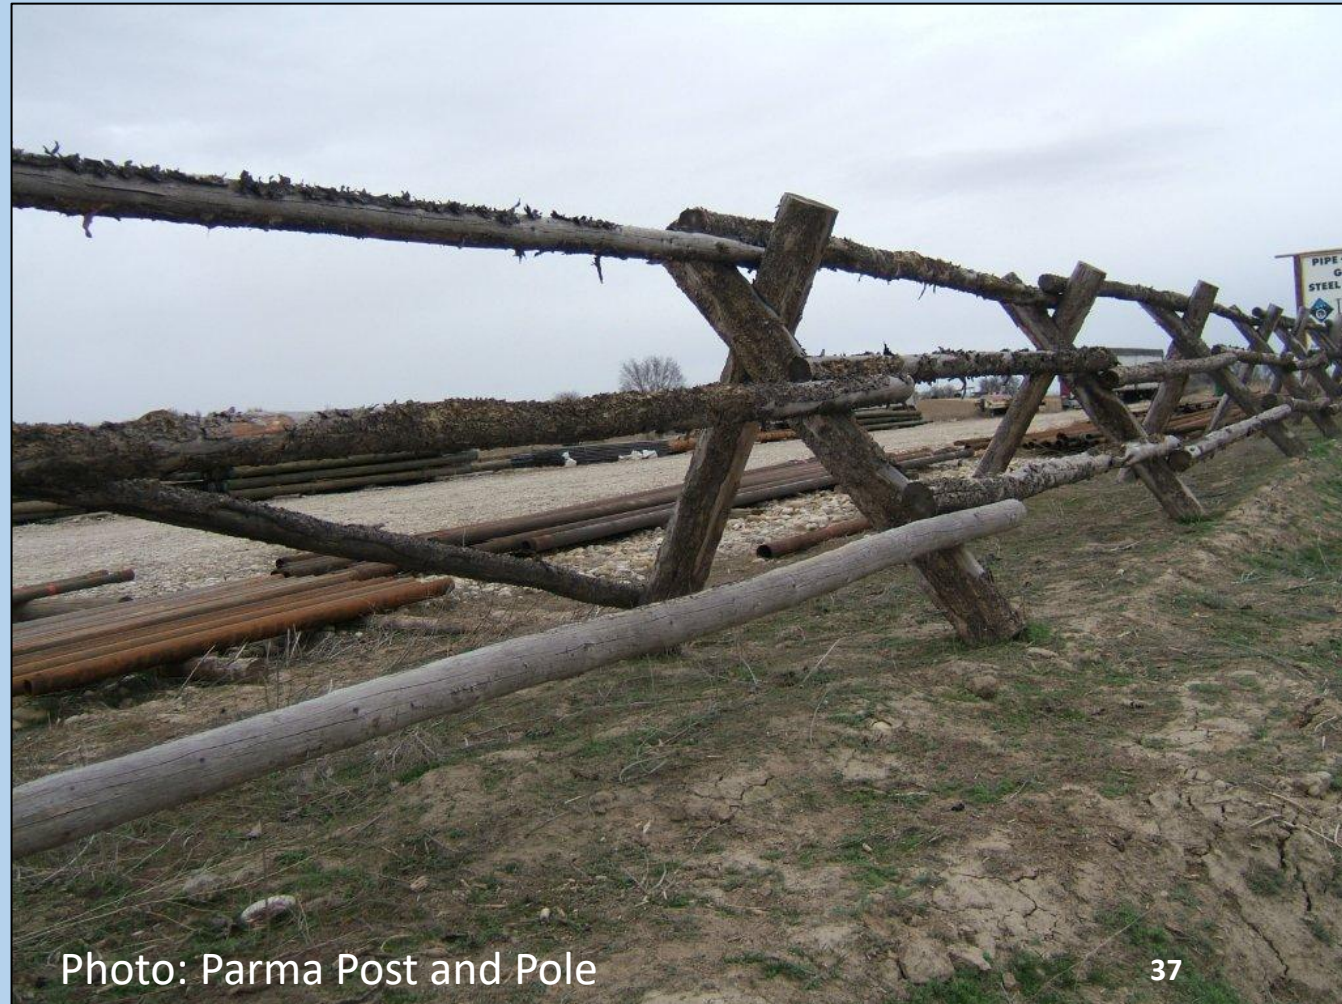
Buck Fence Livestock Exclusion

- Wildlife friendly
- Limited lifespan
- Maintain with on-site materials
- Open Range
